The development of Groningen during the centuries

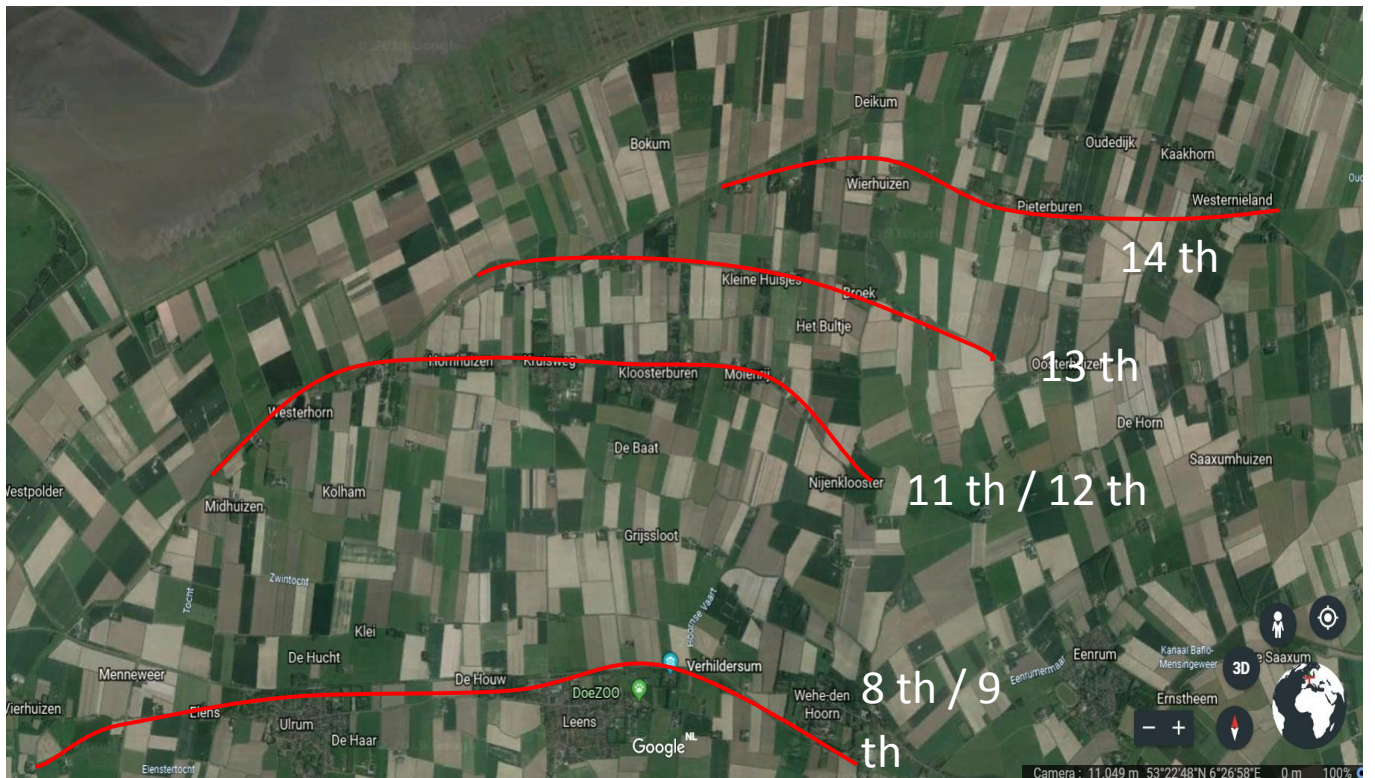
The sealevel started to rise but also the accretion continued and new land developed. The coastline moved further northwards as can be seen by the 'wall' on which the villages Wehe-den Hoorn, via Leens and Ulrum naar Menneweer are situated. This proces repeated itself several times finally resulting in the line Wierhuizen, Pieterburen and Westernieland (probably around 1300 AD) on which a seadike was build.

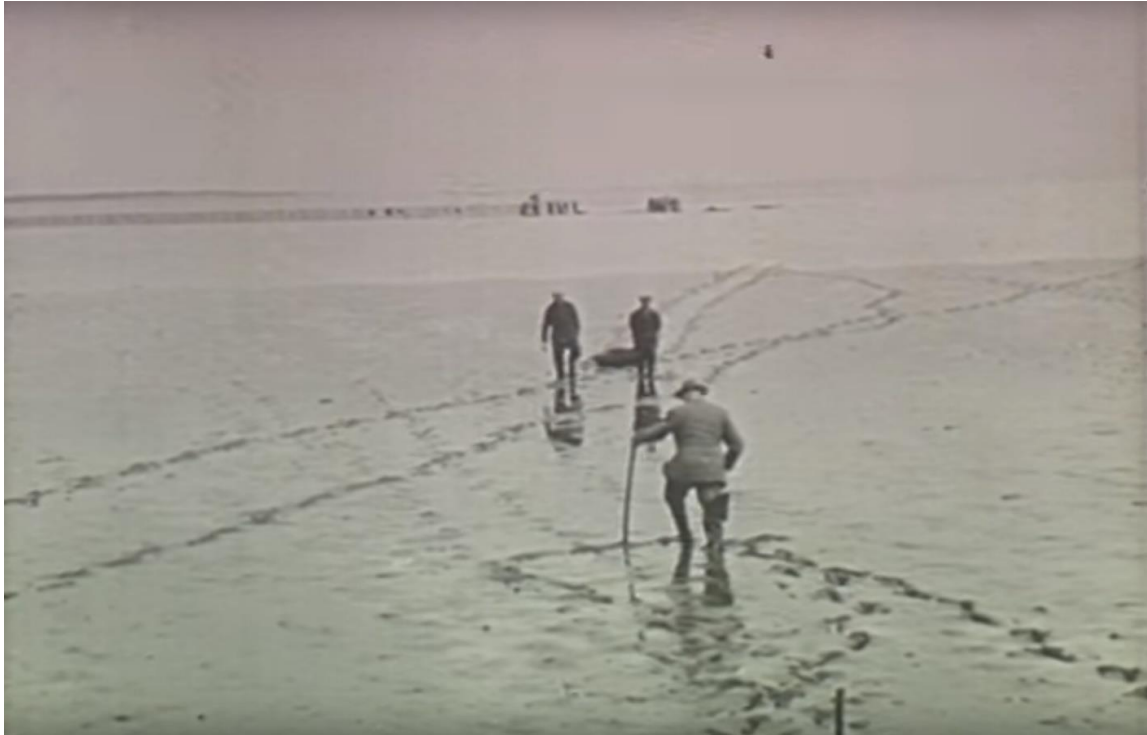
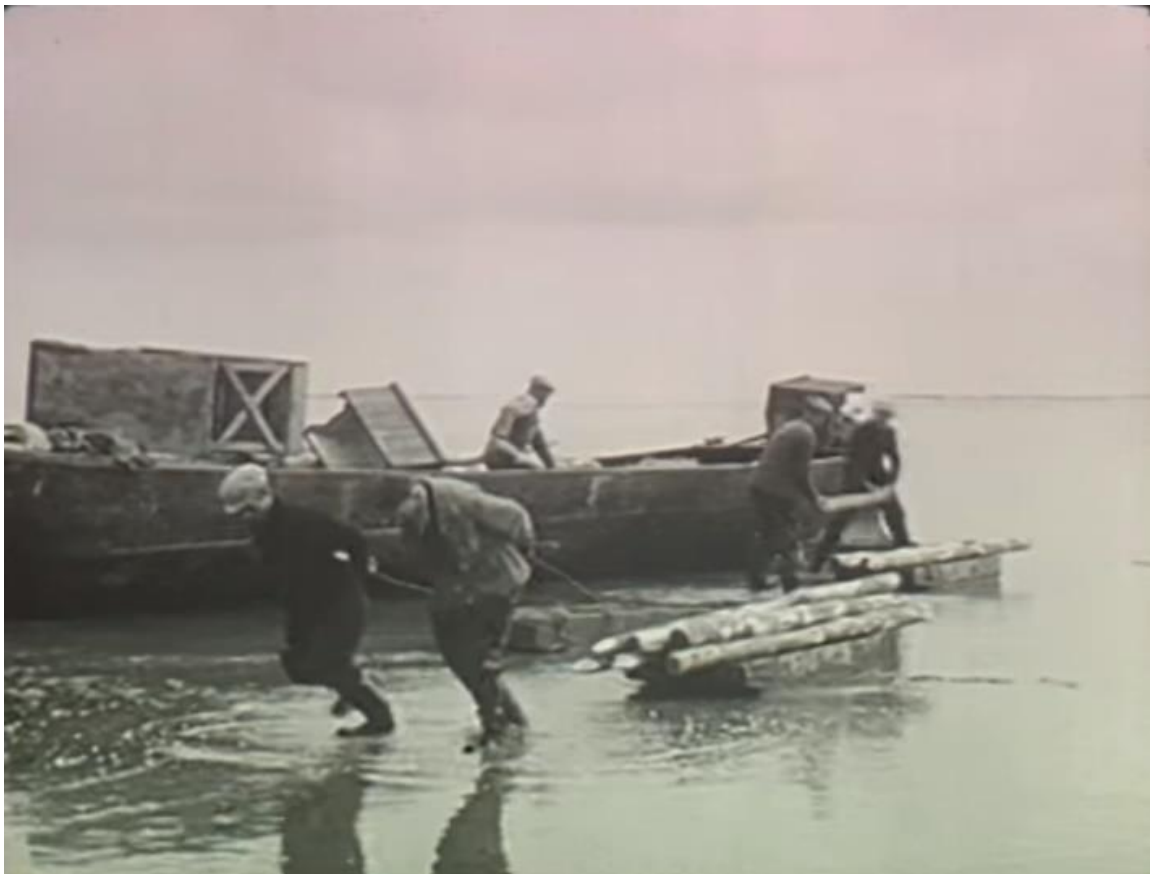
In the beginning of 20th century constructing of forelands from the salt marshes was still a heavy job. Most off the work was done by hand or with simple instruments.

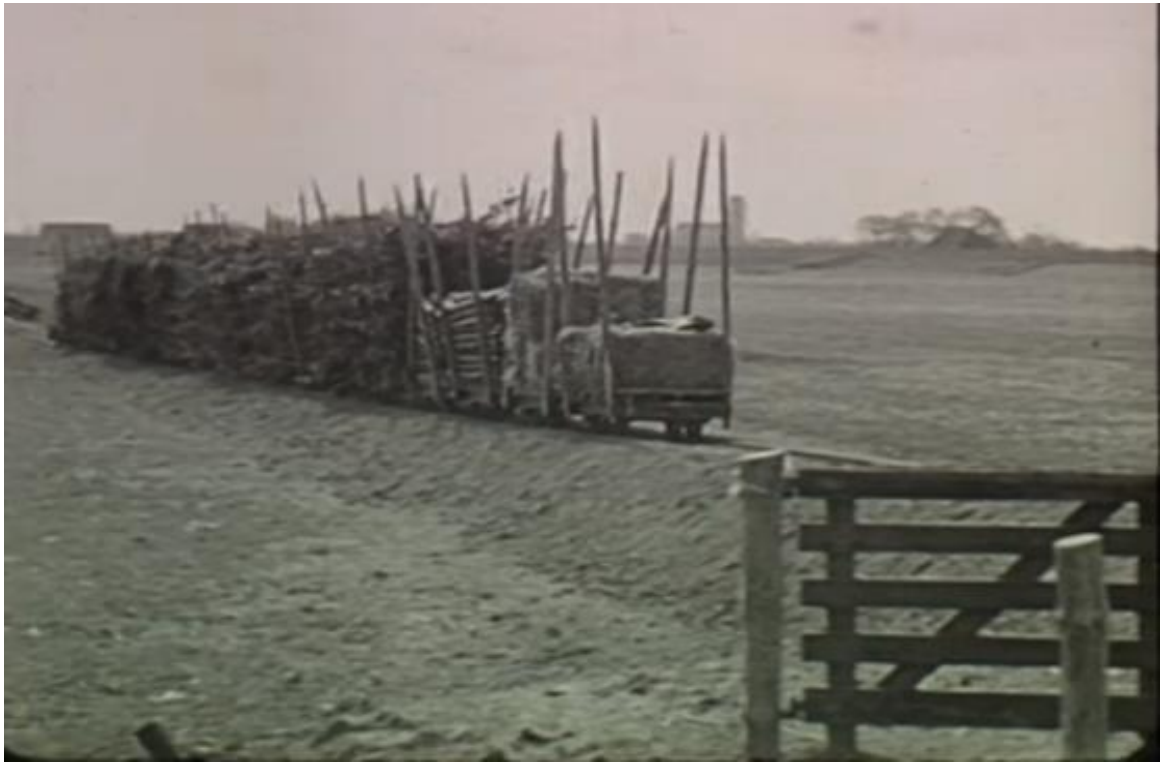
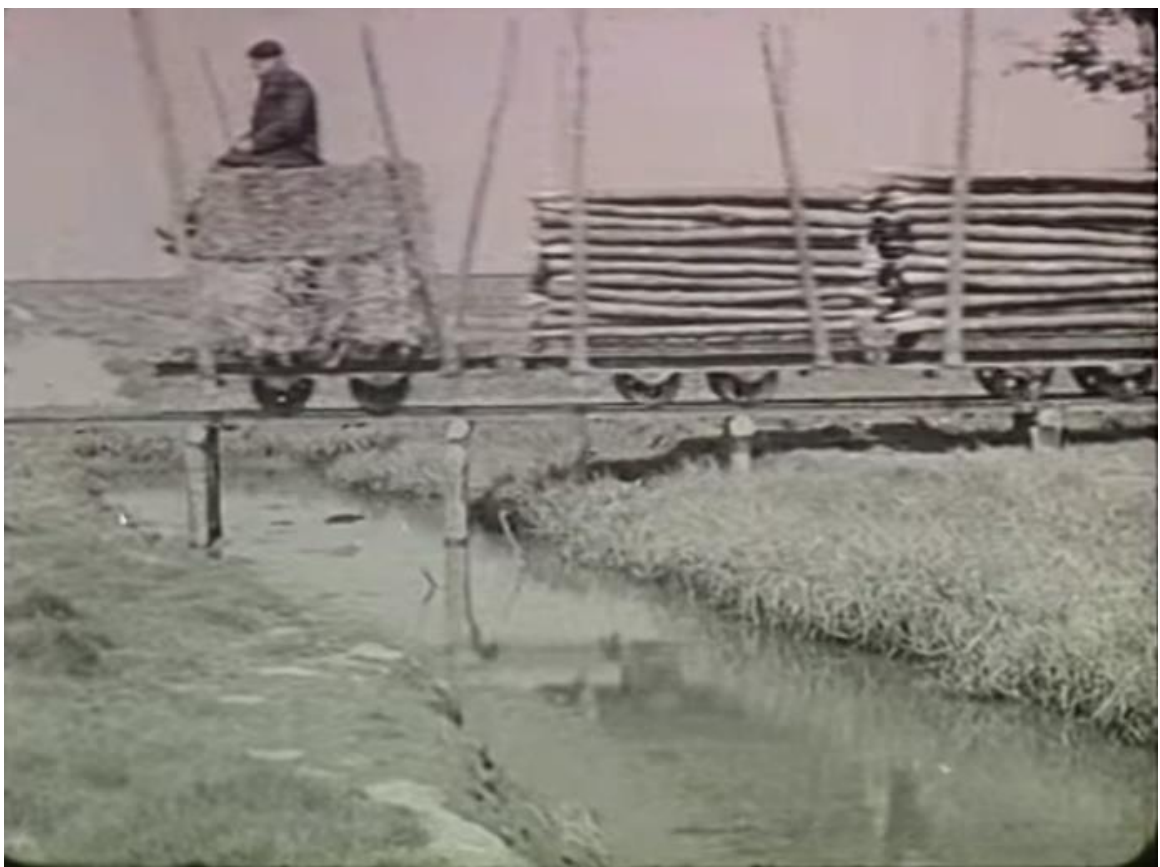
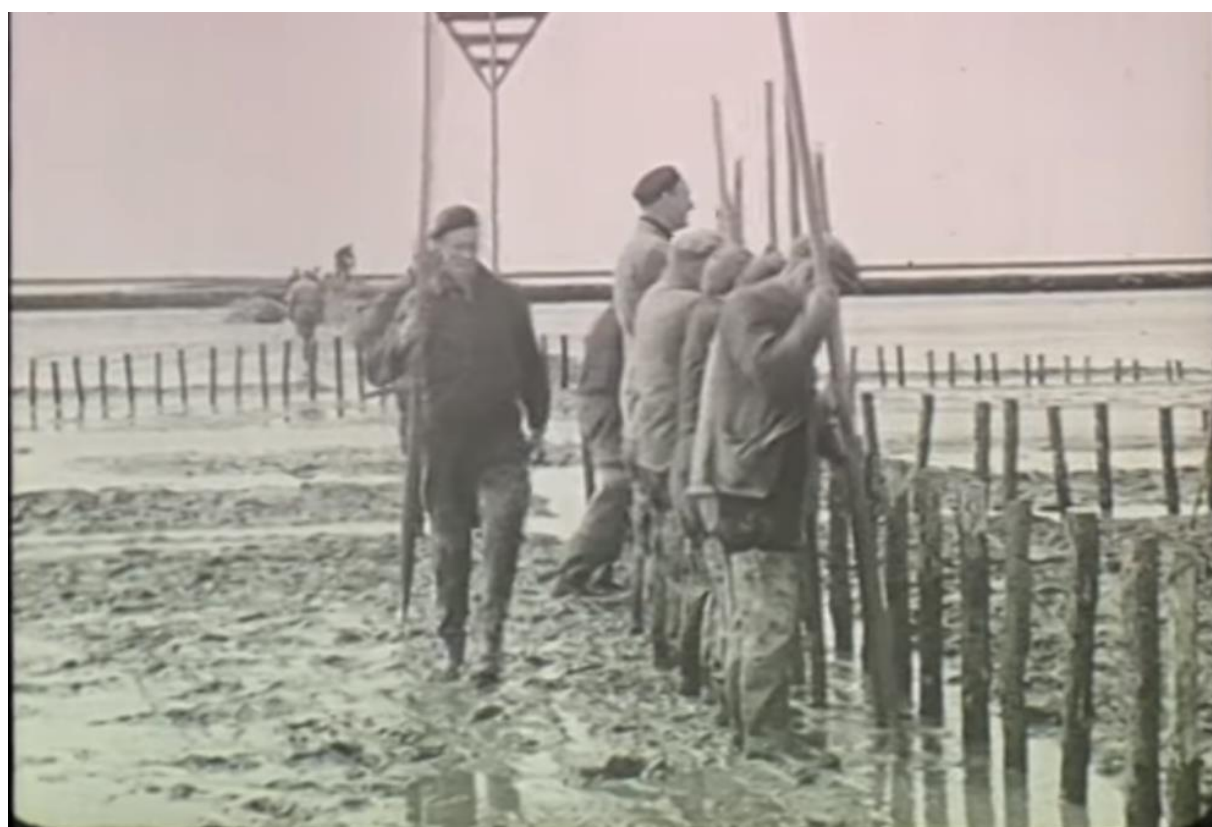
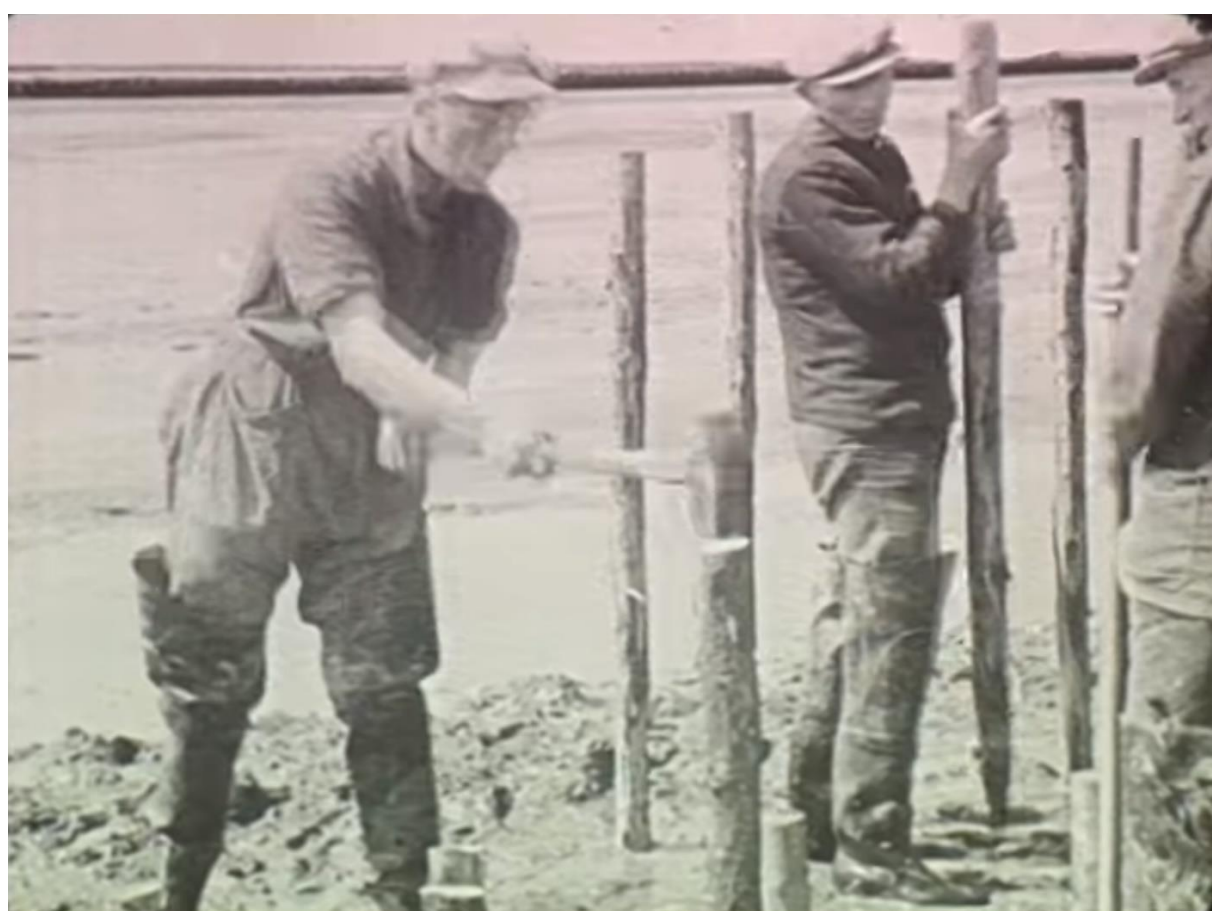
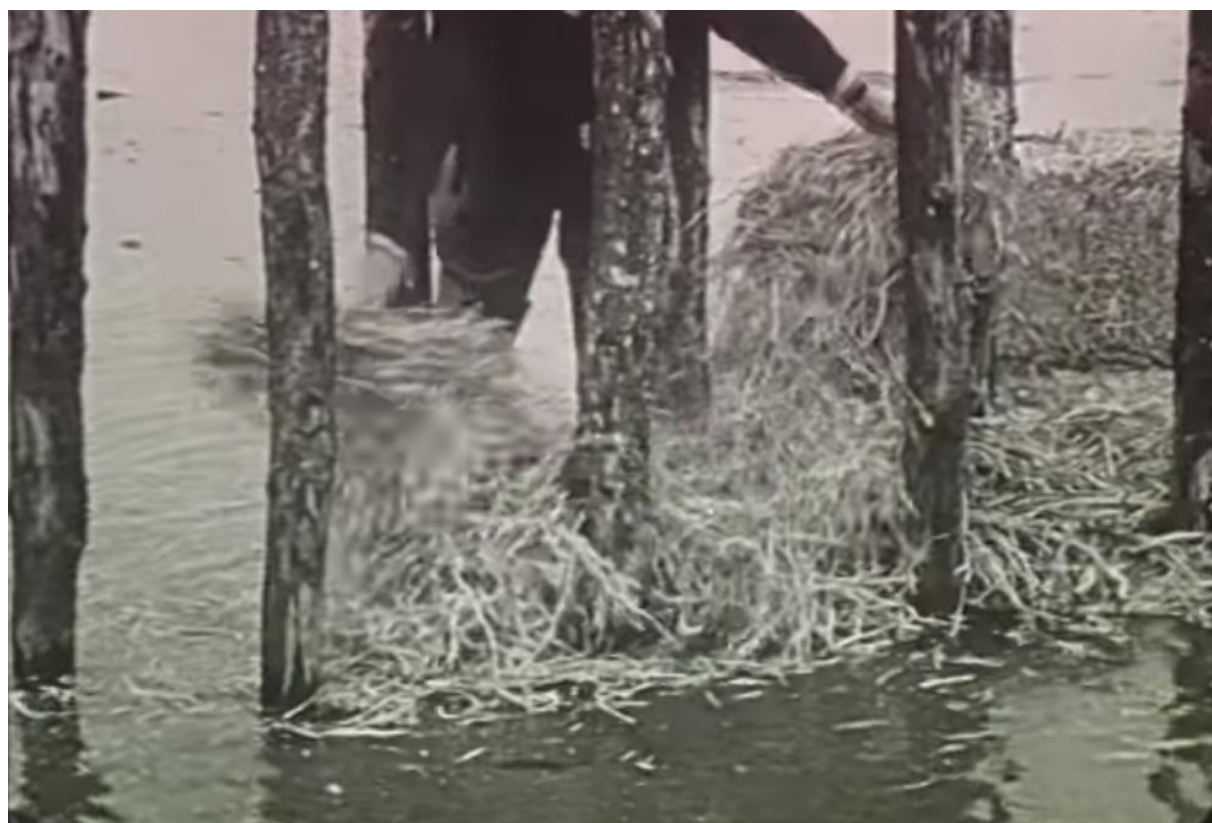
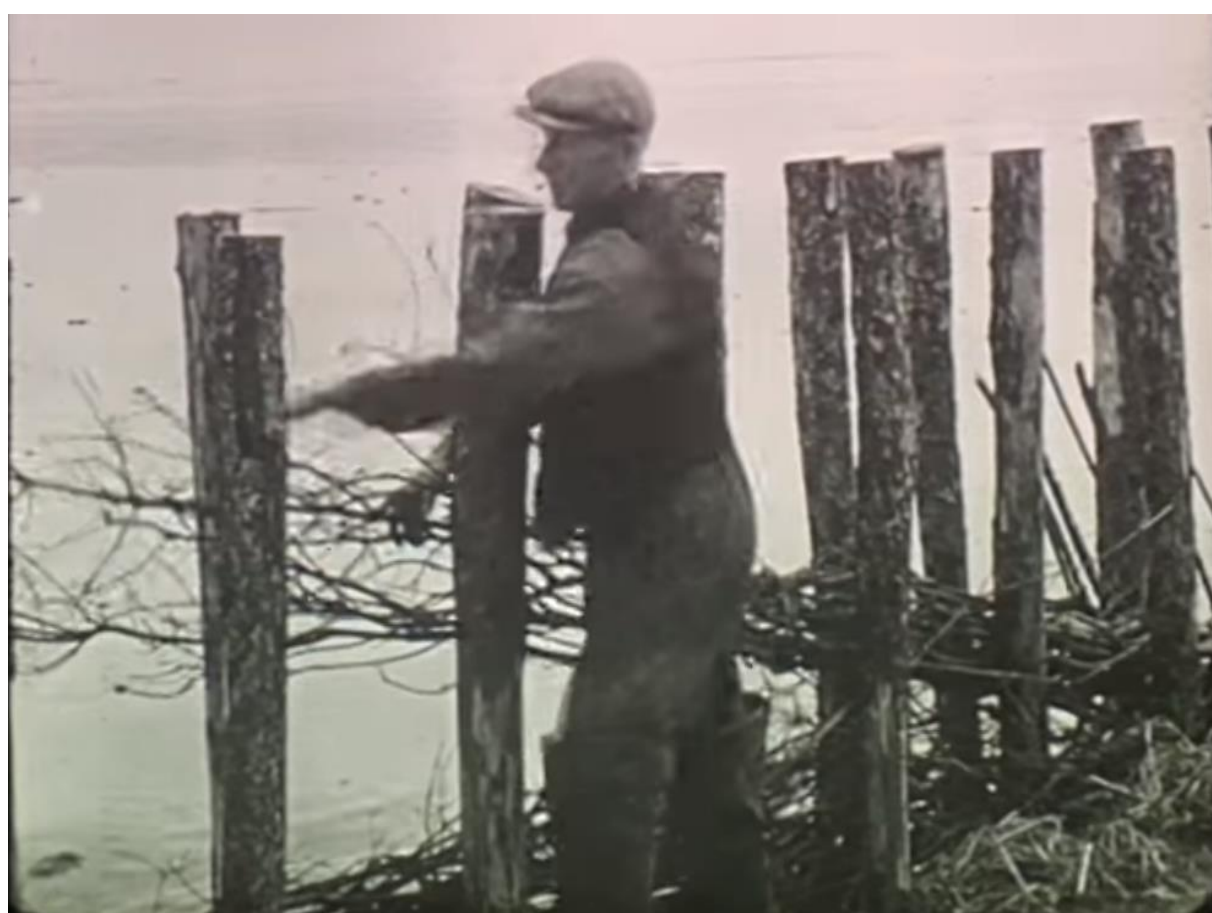
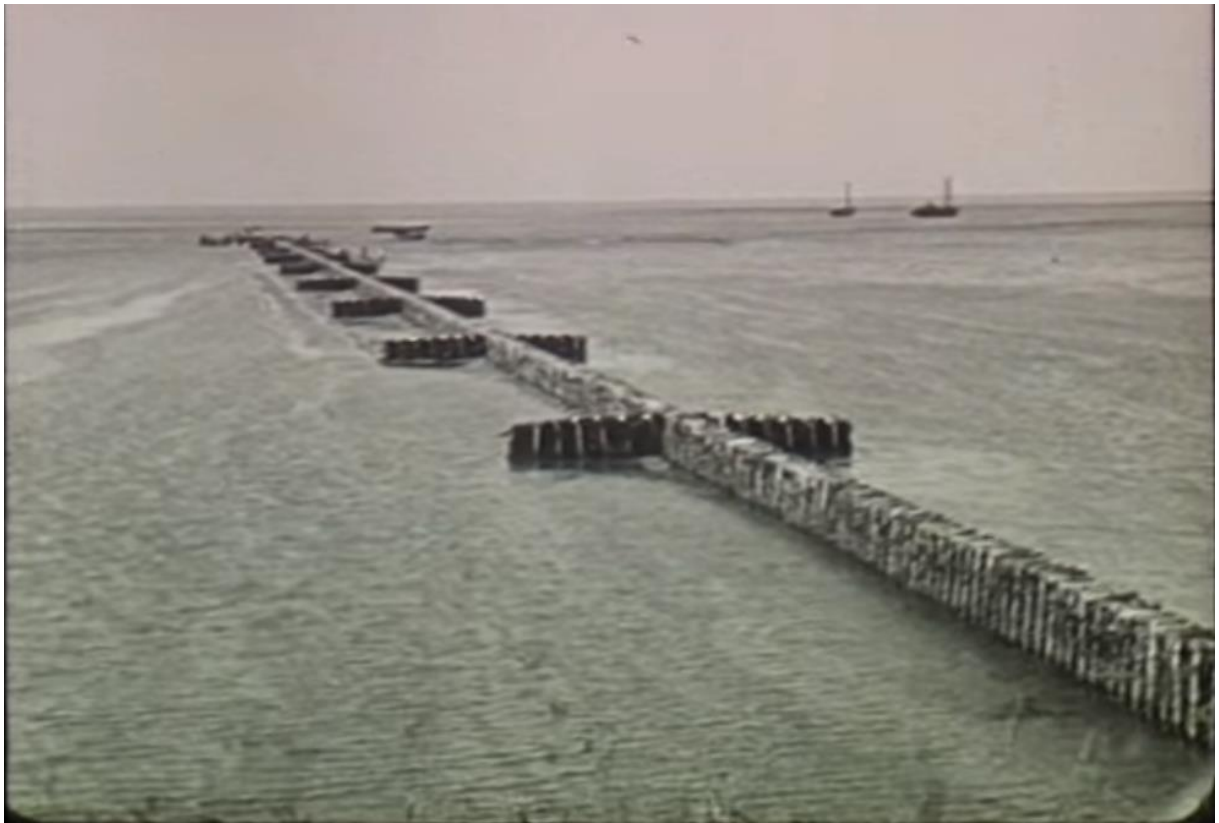
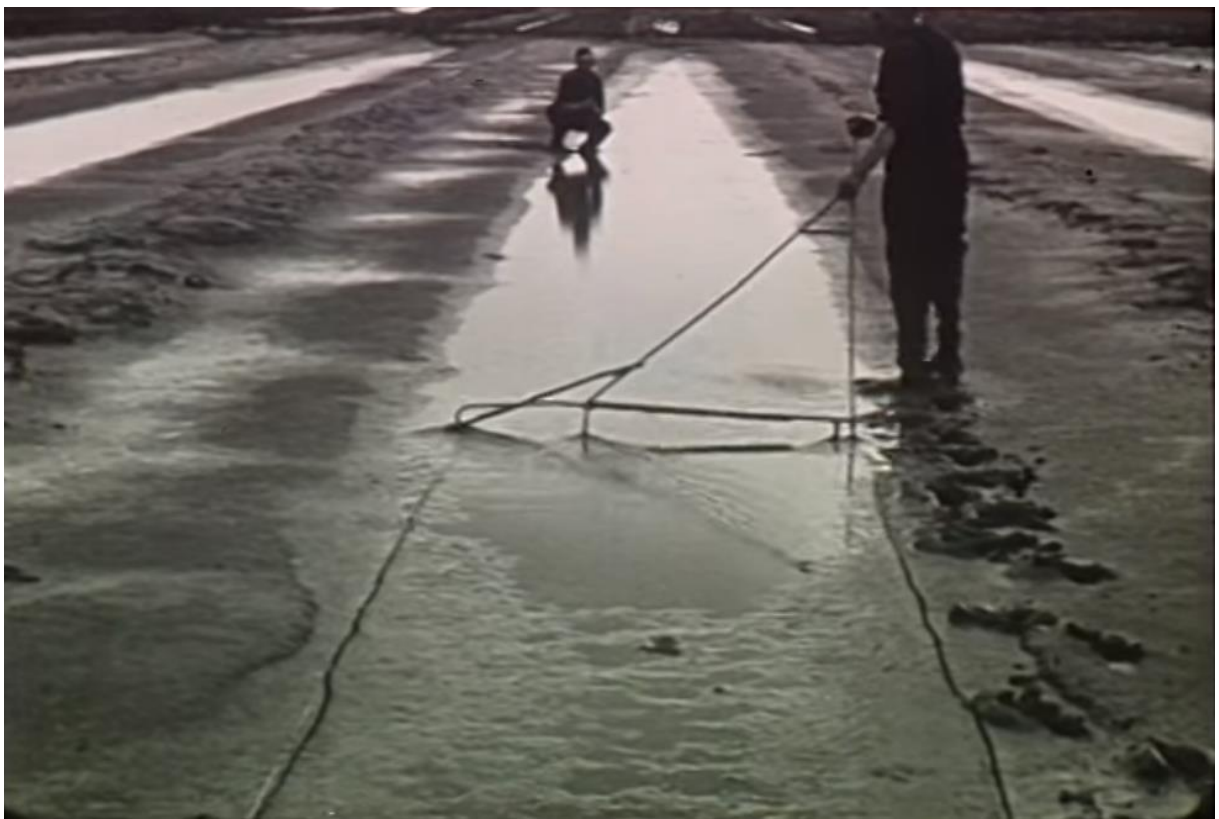
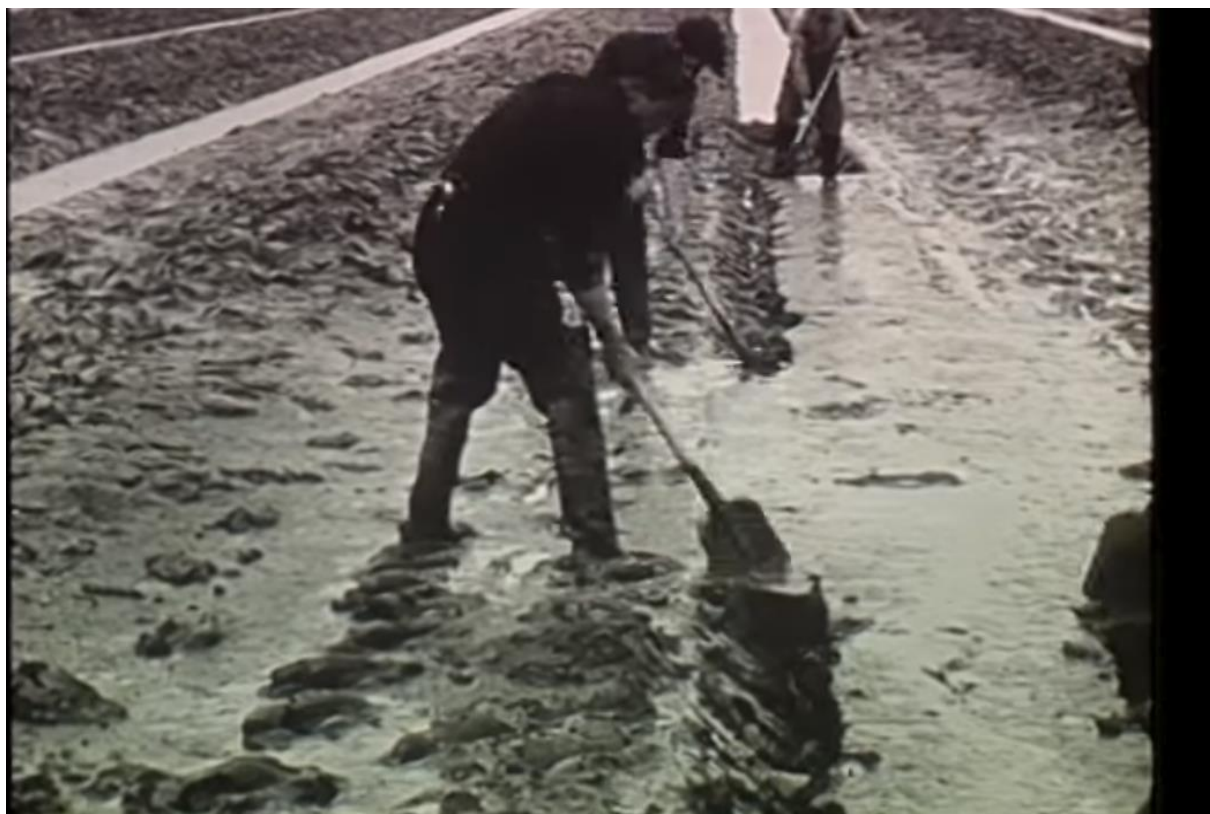
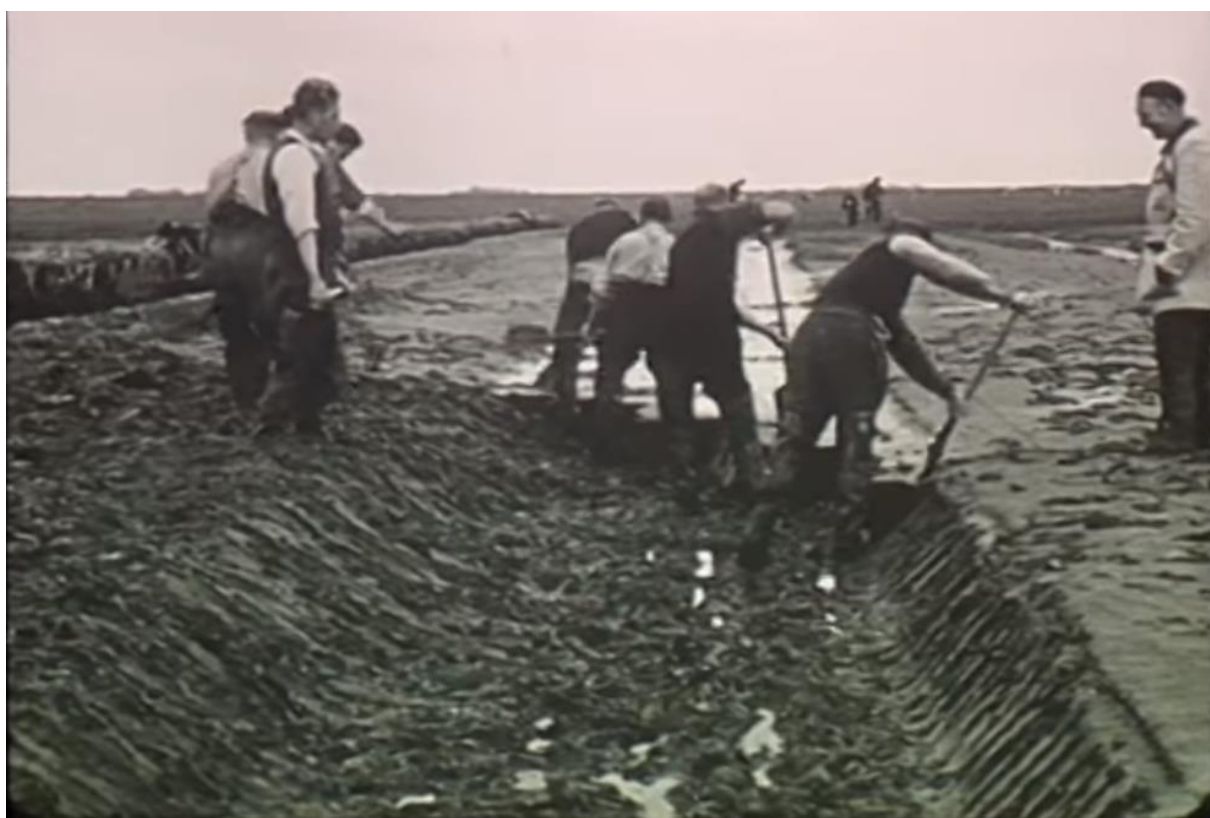
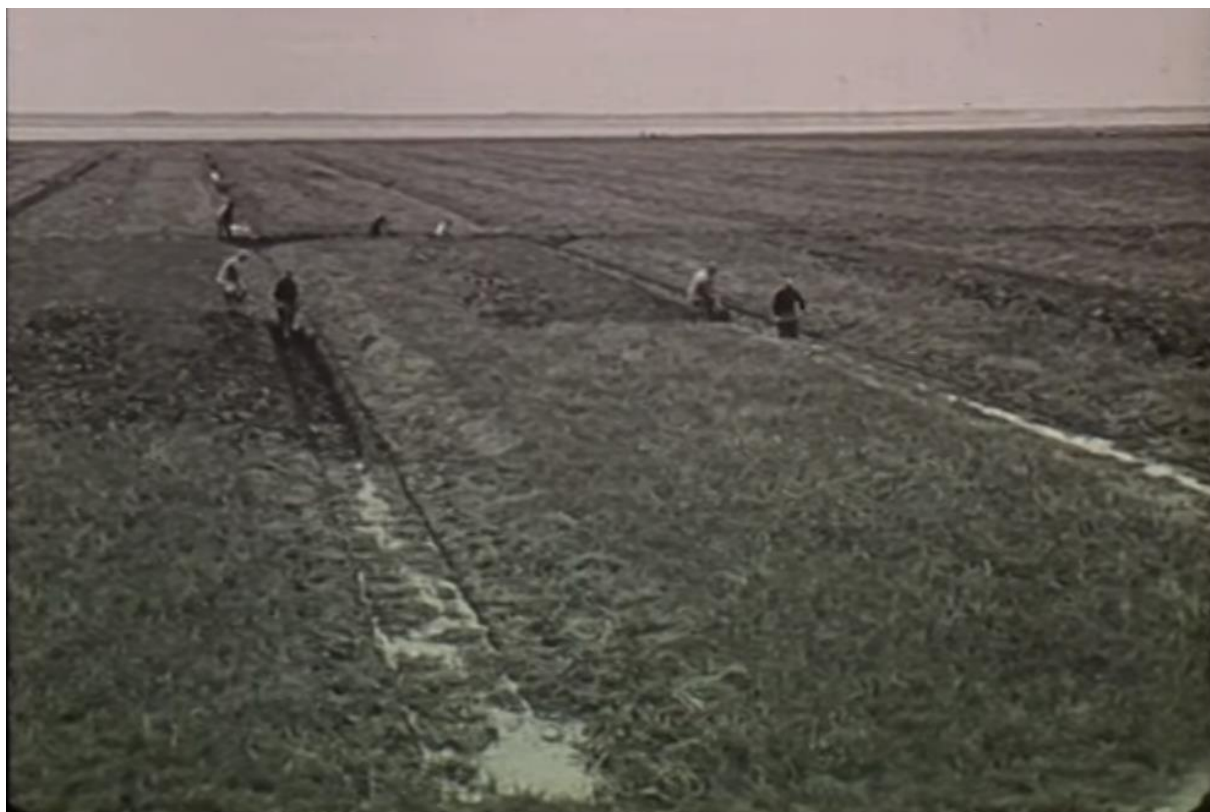
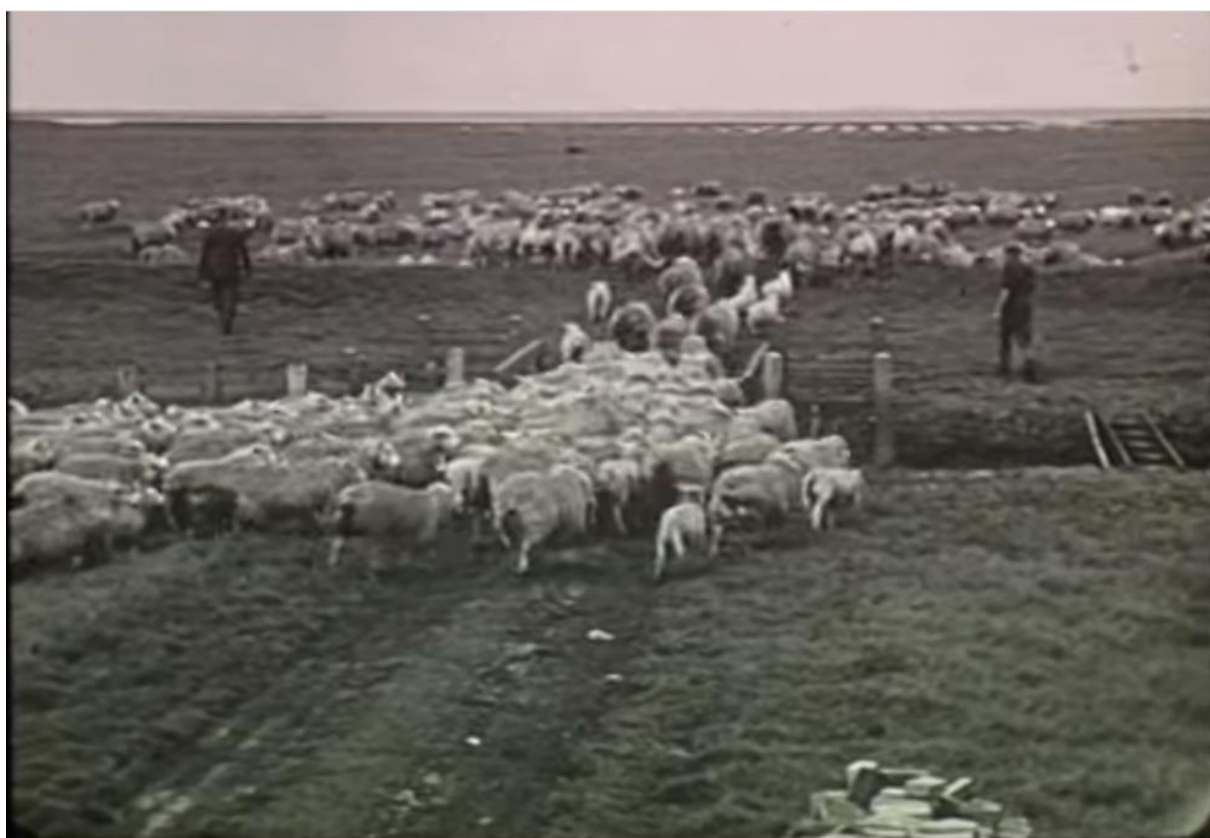
Sometimes transport by train was possible for the first part off the trip

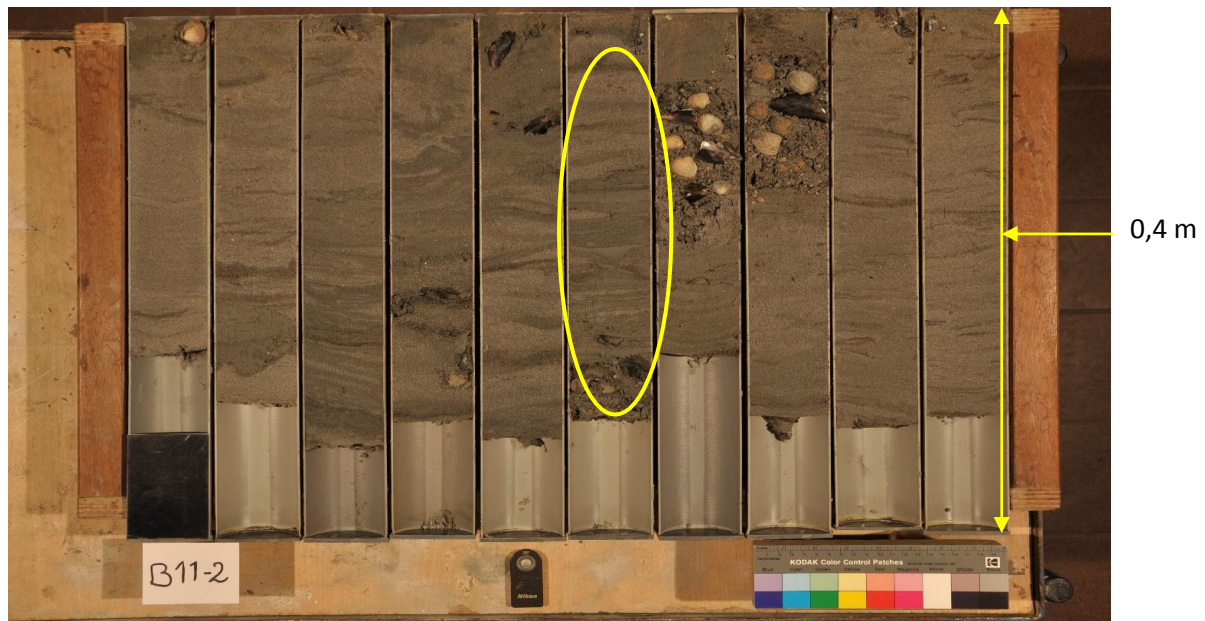
During the centuries the sludgy area of Groningen enlarged very slowly. This resulted in soil that is build up by fine layers of clay and sandmixes (see yellow surrounded area). This characteristic is very important for the failure mechanism piping. In case of gaining more information of our dikes we did a lot of cone penetration tests and soil-drilling tests and took many borehole samples. Since the water permeability is very important for the stability of the dike and the aspect piping we decided to do field tests. For this watertension instruments were placed in the soil under the dike on two locations, one where there is foreland and one nearby where there is no foreland.

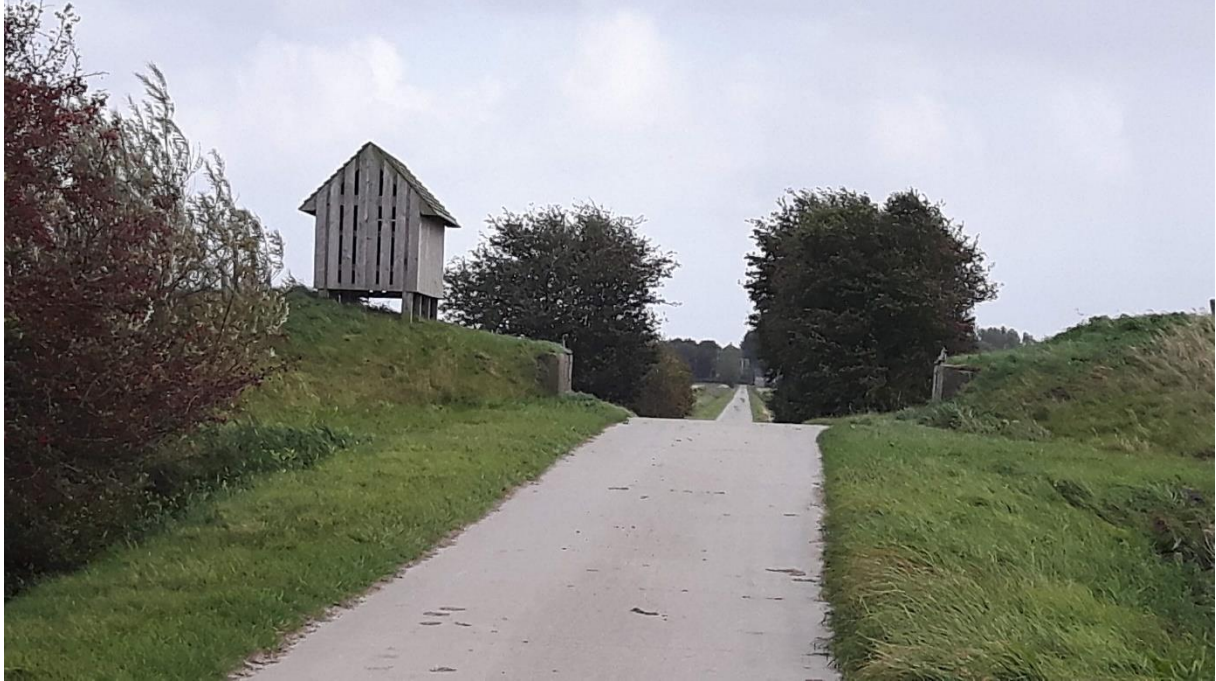
Crossroad of a formal seadike

In the small house wooden beams were kept to close the 'gap' in case of a high water situation. Often clay and/or manure was placed in between the two lines of beams.
